CRITICAL INSTRUCTIONS

Application: **Isuzu Trooper 3.0LD**

WHEN FITTING THIS TURBO, IT IS **CRITICAL** THE FOLLOWING INSTRUCTIONS ARE ADHERED TO:

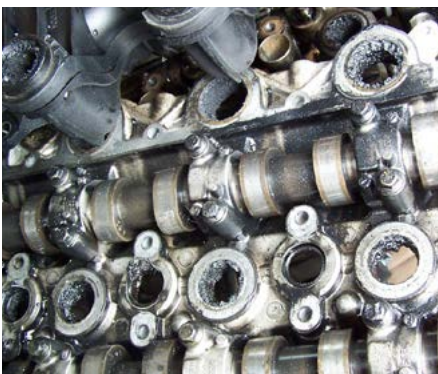
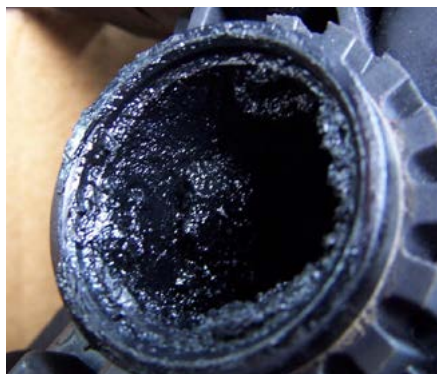
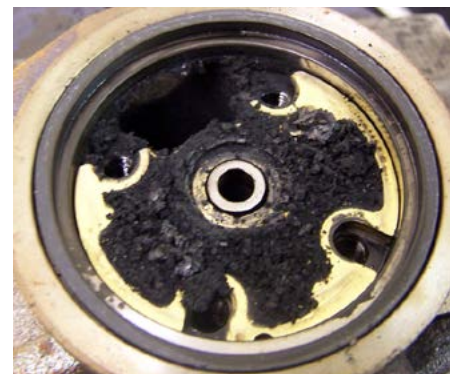
- Experience to date suggests that the carbon build up in this application, which is causing turbos to fail prematurely, is particularly difficult to remove.

The photographs above are from an engine which has completed approximately 110,000 miles. The engine has been serviced by an approved dealer at the correct service intervals using the manufacturer's recommended oil and filters. **This engine has caused two new turbocharger failures in a very short time.**

- Before removing old turbocharger carry out 2 engine flushes using FLUSHING OIL not flushing additive. Change oil filter each time. **Note:** Condition of turbocharger and oil leakage needs to be assessed before this operation as not to cause excessive oil leakage allowing engine to run on own oil.

- Sump must be **removed** and cleaned
- Check that engine has latest specification sump
- Replace dipstick if vehicle fitted with yellow plastic version. Latest spec. is white with orange grip.

- Oil strainer (pick up) **must be removed and replaced** due to residual carbon/sludge build up
- Oil pump should be **removed and checked**.
- Oil cooler and filter assembly should be **removed and cleaned**

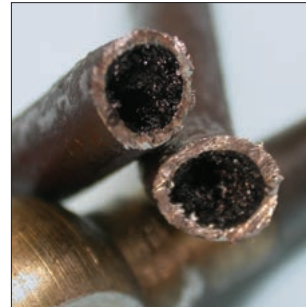
The oil feed pipe tends to become restricted by carbon over time, due to its close proximity to the exhaust system, which then reduces oil flow to the turbocharger. Failure to replace the oil feed pipe may result in damage to the turbocharger.

We strongly recommend the Oil Feed Pipe is changed before starting any work. If you have not received the Oil Feed pipe kit with your turbocharger, please contact your supplier to purchase.

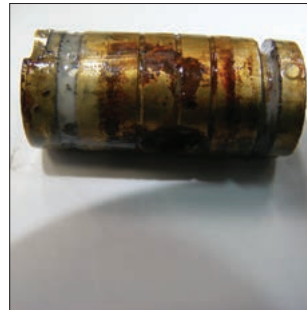
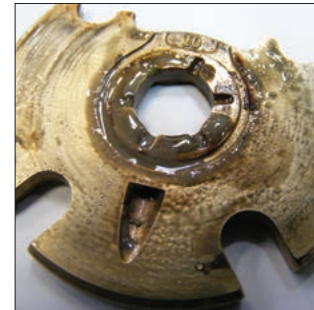
The water pump and oil cooler are known to fail on this engine, allowing the oil and water to mix.

This reduces the lubricating properties of the oil, resulting in turbocharger failure.

It is essential that the water pump and oil cooler are checked before fitting the new turbo.

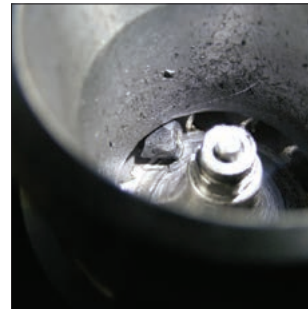
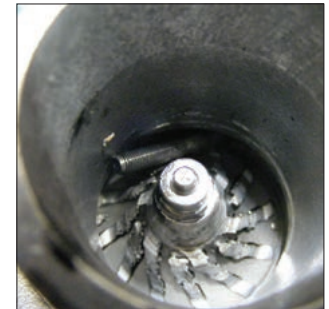
Failure to carry out this operation can lead to the new turbocharger being damaged on start up or at low milage.

Prior to fitting the new turbocharger remove the air intake and engine breather pipework, situated between the turbocharger and the air filter box.

Check the pipework for debris and/or damage and clean/replace as necessary.

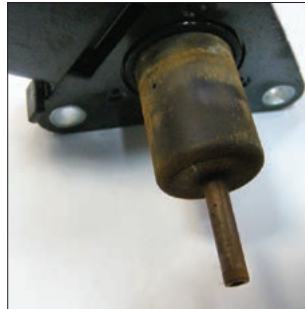
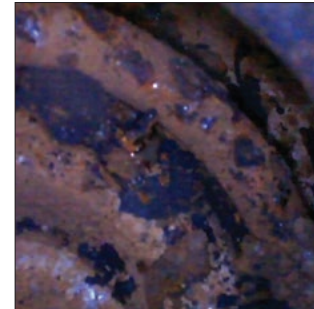
- **To stop water ingress into the actuator/position sensor, it is essential that the following checks are carried out:**

1. Inspect turbo control solenoid valve (Part Number 1618C9) for correct operation.
and signs of water ingress – replace as required.
2. Inspect condition and connections of vacuum pipework between control solenoid valve and turbocharger – replace as required.
3. Ensure soundproof scuttle trim is secured correctly.

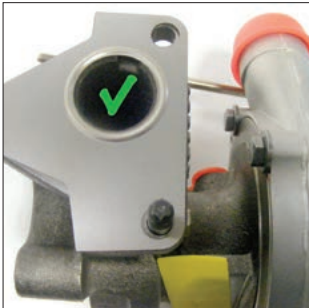
Correct fitting

Care should be taken when fitting the exhaust inlet gasket as it is possible to fit this incorrectly and restrict the flow of exhaust gas to the turbocharger.

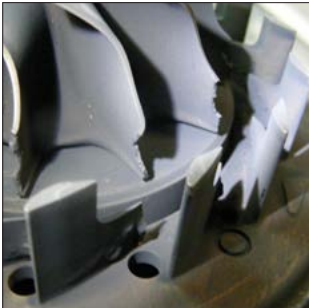
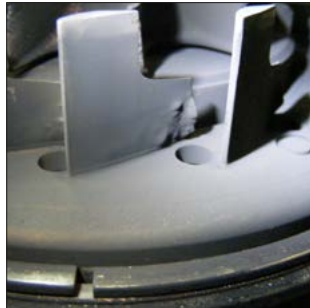
There have been issues with the EGR valve failing on this application, resulting in damage to the turbocharger. Failure to check/replace the valve may result in immediate damage to the turbocharger.

Damage caused by failure of the EGR valve.

- **Check/Replace EGR valve before fitting turbocharger**
