CRITICAL INSTRUCTIONS

Application: **Isuzu Trooper 3.0LD**

WHEN FITTING THIS TURBO, IT IS **CRITICAL** THE FOLLOWING INSTRUCTIONS ARE ADHERED TO:

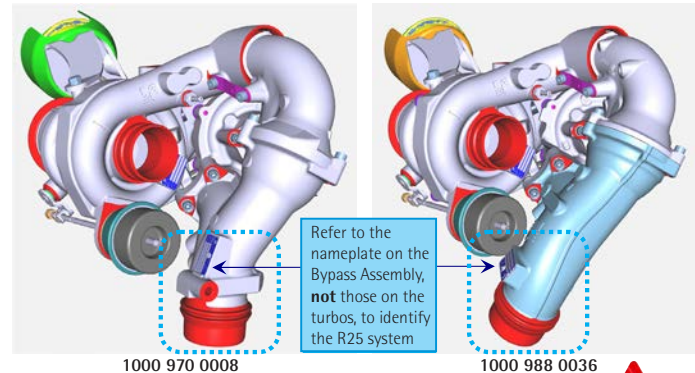
This is due to a geometrical difference between the two products and without the additional products, the replacement turbo will not be able to be fitted.

*Use -5182 if vehicle has optional equipment codes H08, N63 or HK4
